# Parts and Material Analysis Report

Customer	Braun Electronic Components LLC	Part Number	MK12DX256VLK5
Customer PO	000920-A	Manufacturer	NXP
Customer Address	1500 W Main St Suite 200, Sun Prairie, WI 53590 USA	Date/Lot Code	1750
Report Date	2/21/2023 4:56:42 PM	Quantity Revd	total: 1440 test: 3640
Revision	0	AAA WO #	W2302130002

Device	<p><b>ARM® Cortex®-M4 Kinetis K10 Microcontroller IC 32-Bit Single-Core 50MHz 256KB (256K x 8) FLASH 80-FQFP (12x12)</b></p> <p>Speed 50MHz  Connectivity I<sup>2</sup>C, IrDA, SPI, UART/USART  Peripherals DMA, I<sup>2</sup>S, LVD, POR, PWM, WDT  Number of I/O 60  Program Memory Size 256KB (256K x 8)  Program Memory Type FLASH  EEPROM Size 4K x 8  RAM Size 32K x 8  Voltage - Supply (Vcc/Vdd) 1.71V ~ 3.6V  Data Converters A/D 24x16b; D/A 1x12b  Oscillator Type Internal  Operating Temperature -40°C ~ 105°C (TA)  Package / Case 80-LQFP  RoHS Status ROHS3 Compliant  Moisture Sensitivity Level (MSL) 3 (168 Hours)  REACH Status REACH Unaffected  ECCN 3A991A2  HTSUS 8542.31.0001</p>
Case	<b>80-Pin FQFP</b>
PDF	<a href="https://www.nxp.com/docs/en/data-sheet/K12P80M50SF4.pdf">https://www.nxp.com/docs/en/data-sheet/K12P80M50SF4.pdf</a>
Datasheet	<b>Rev. 4.1

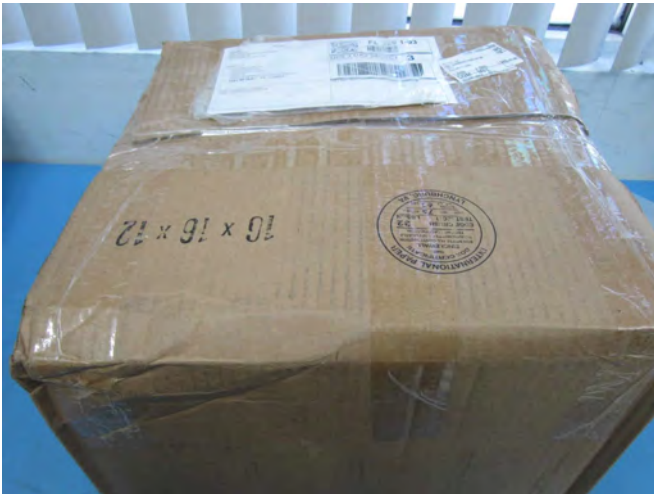
**Incoming Box**

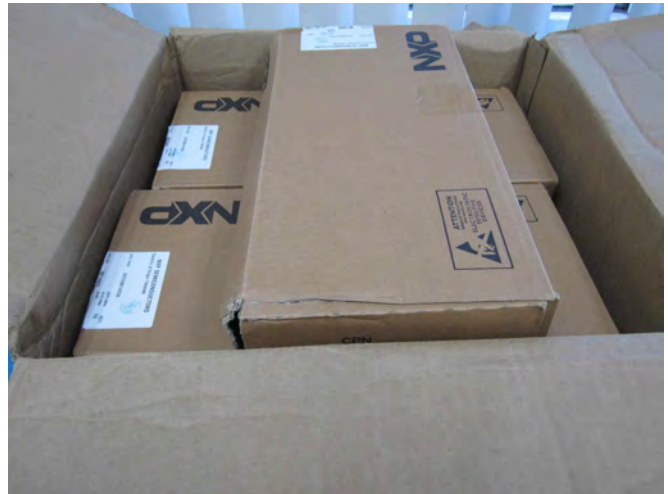
**Package Condition**

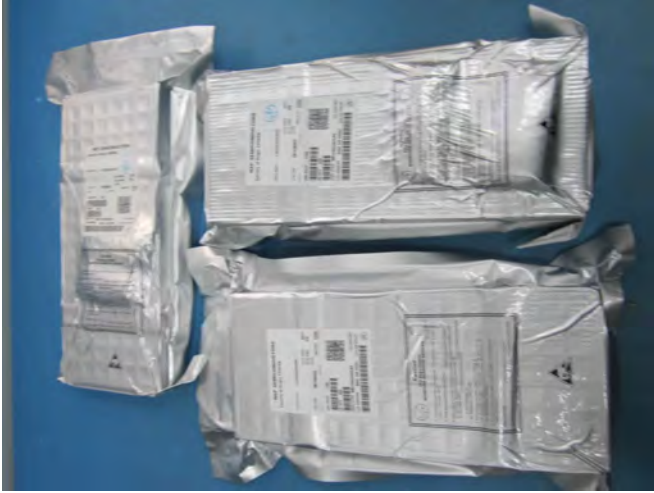
ESD Protection

<b>Date:</b>	2/13/2023 3:15:06 PM	<b>Tech:</b>	amber
<b>Device Count:</b>	1440	<b>Date/Lot Code:</b>	1750
<b>Weight:</b>	27.0000 lbs	<b>ESD Protection:</b>	Present
<b>Moisture Protection:</b>	Present WITH Indicator and Desiccant	<b>Carrier Type:</b>	Tray

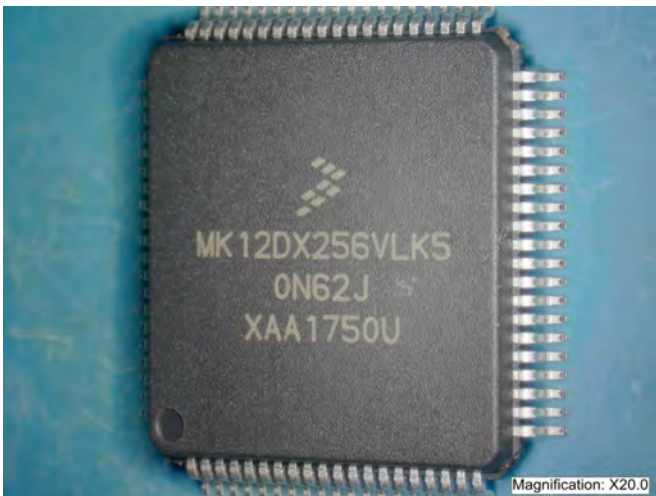
Top Marking

Part markings were consistent throughout the samples inspected and matched manufacturer's ordering information.

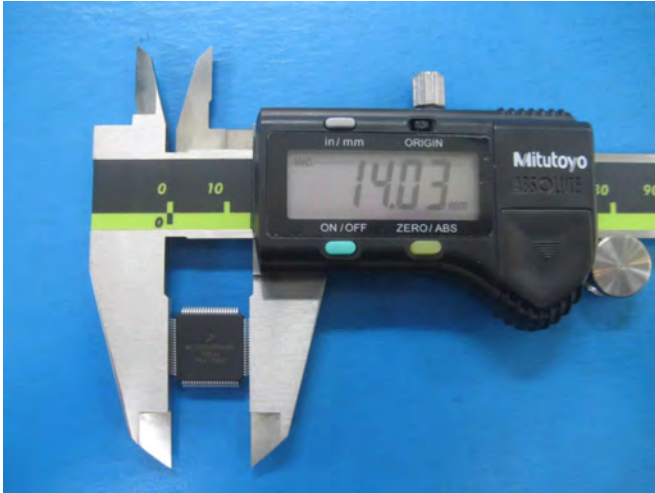
**Length**

Measurement	Type	Average	Minimum	Maximum
Length (mm)	Specification	14.00	—	—
	Measurement	14.05	14.00	14.07
Width (mm)	Specification	14.00	—	—
	Measurement	14.04	13.99	14.09
Thickness (mm)	Specification	—	—	1.60
	Measurement	1.49	1.46	1.50

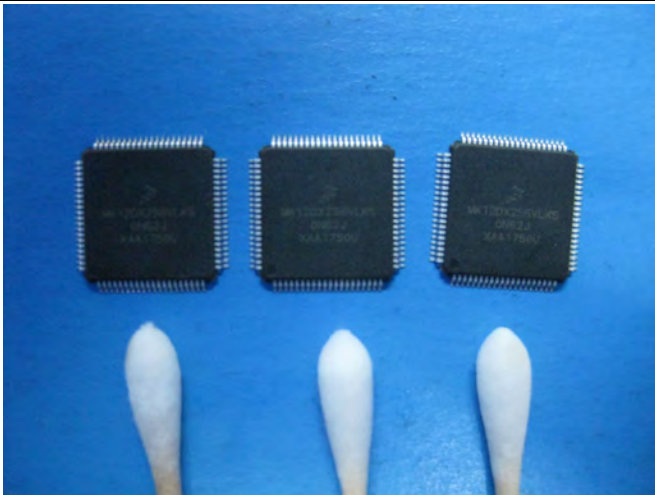
After Permanency

Marking Permanency Test results were negative - no markings were removed.

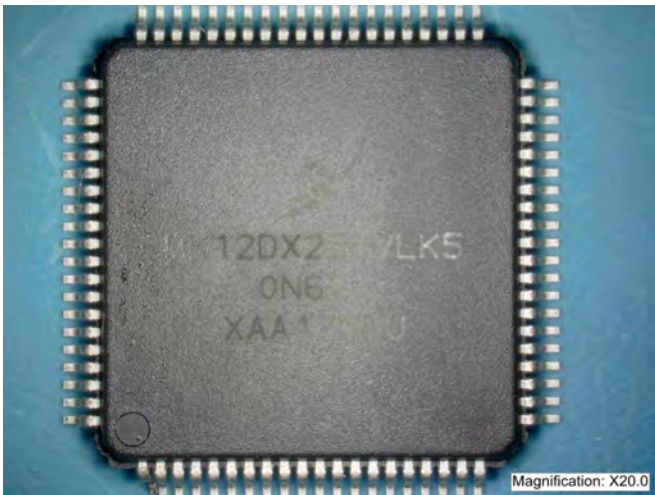
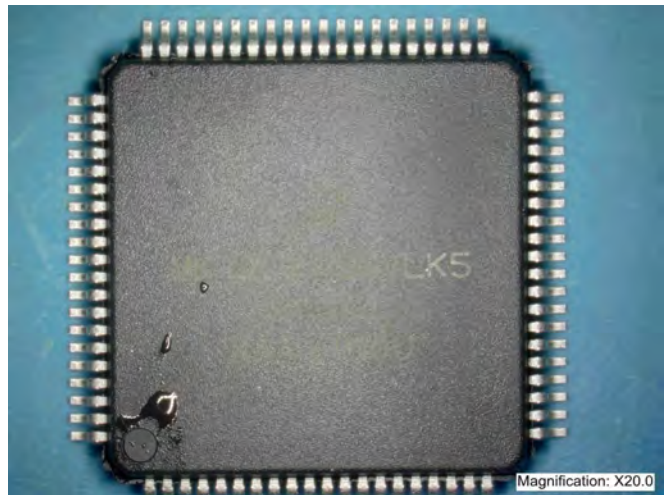
After HCT-1

HCT-1 Test results for resurfacing were positive - residue was deposited on the swab, no sanding marks or previous markings were exposed.

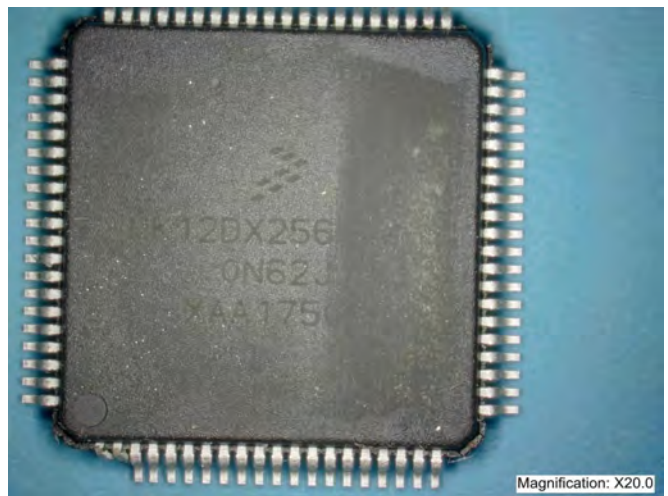
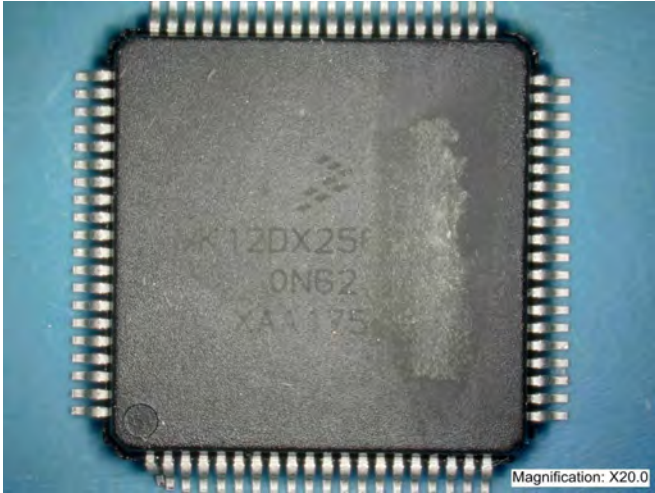
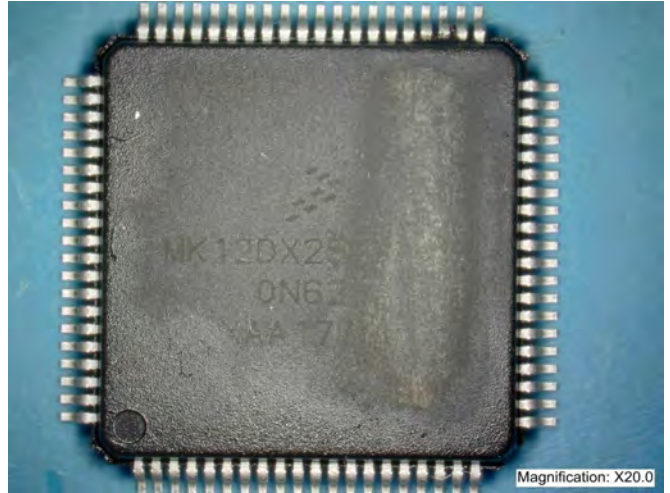
After HCT-2

HCT-2 Test results for resurfacing were positive - residue was deposited on the swab, no sanding marks or previous markings were exposed.

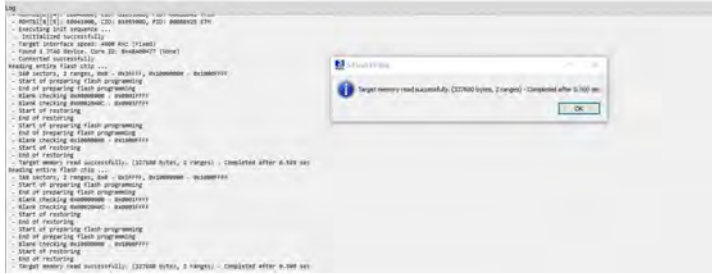
Sample Device Passing Memory Read
